Land Surface Rehabilitation Research in Antarctica

Kiernan, K. and McConnell, A. (2001). Land surface rehabilitation research in Antarctica. *Proceedings of the Linnean Society of New South Wales* **123**, 101-118.

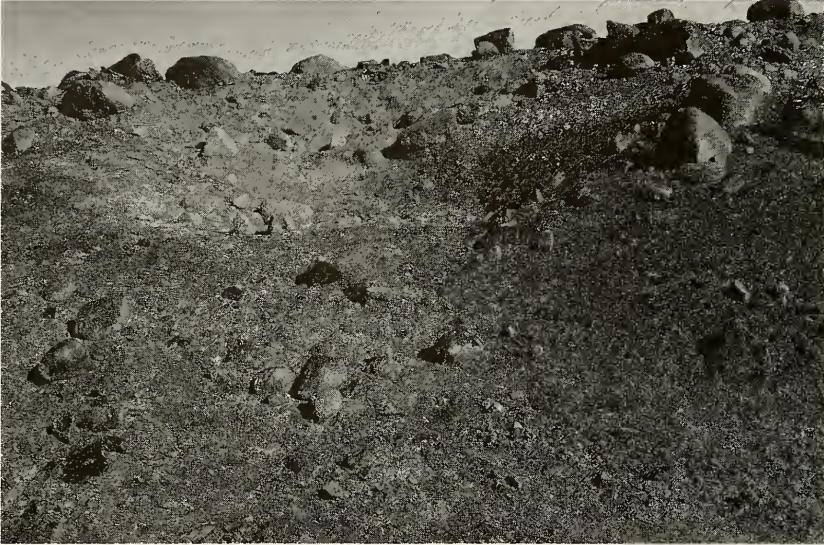
Figure 2a.

Immediately after rehabilitation on 24 January 1997 the new disturbance was difficult to distinguish from the earlier excavation (Fig. 2a). The newly-disturbed surface was a mixture of unweathered sediments from various depths. The colour contrast between the newly disturbed and previously disturbed surfaces was moderate at two Munsell units, but this did not reflect the real visual impact of the original excavation on the broader landscape. Because the depression in the active layer caused by the earlier excavation was not filled, the potential remained for continued permafrost melting.

Figure 2. Big Ditch site (site 2): (a) in January 1997, immediately after disturbance and rehabilitation of the old excavation site; and (b) in December 2000, showing fine sediment and salt deposited by meltwater still being released from the permafrost.

It proved impracticable to do more than seek to ensure our re-disturbance was no more visually evident than was the much larger artificial face and hole in which it was sited. The original large excavation could not be filled and the overall slope restored because the spoil from the earlier excavation had spilled downslope and been redistributed by wind and meltwater such that little could be retrieved without risking significant additional disturbance. An attempt was made to reduce visual impact by using the very small volume of spoil that could be retrieved to mimic the natural slopes to either side. Efforts were made to reproduce the slope angle, colour and texture of the face of the earlier excavation, itself very conspicuously artificial. Old discarded scraps of latex and hessian were also removed. Some larger rocks retrieved from the earlier spoil were distributed along the top of the face to mimic the adjacent pattern of glacial boulders spilling onto the upper scarp.

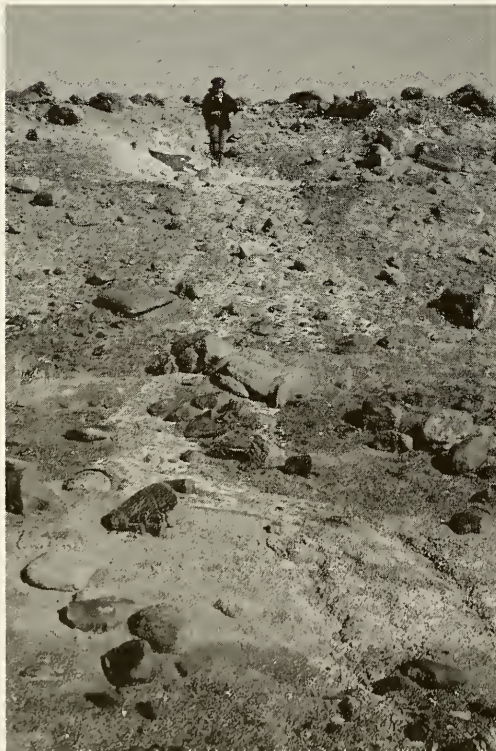
Figure 2b.

When the site was monitored on 11 December 2000 some further movement of the lower part of the face by solifluction was evident. Discolouration of downslope areas by salt and fine sediment was more pronounced than in 1997 (Fig. 2b). These observations were interpreted as indicating that thawing of the permafrost had been accelerated by renewed disturbance of the active layer. Hence, the structural and cosmetic rehabilitation attempted had not been sufficient to redress the effects of the re-disturbance superimposed upon the original un-rehabilitated excavation.

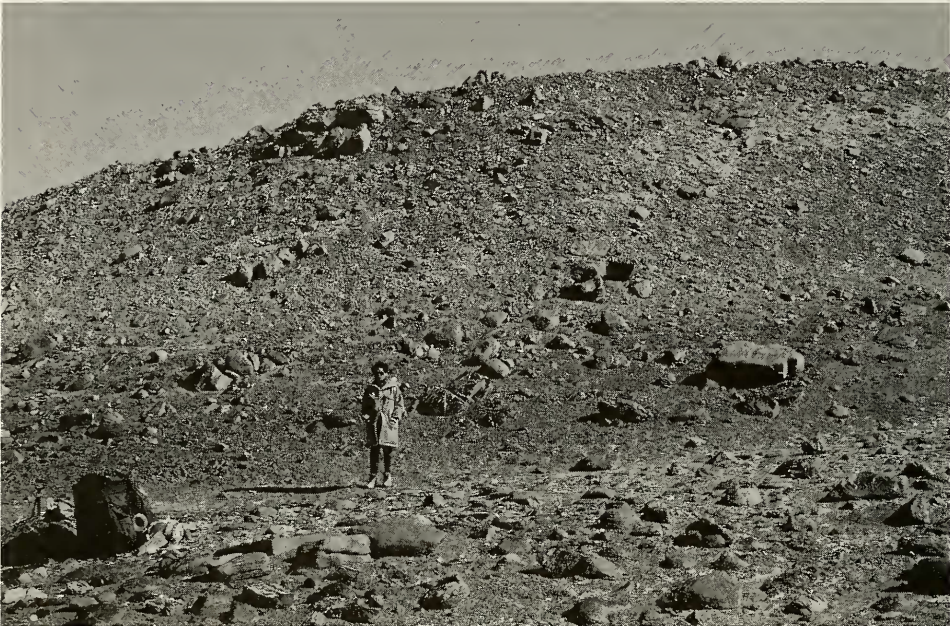
Figure 3a.

A trench 22 m long and 30-40 cm wide with a series of benches along its length was excavated down the face of a scarp 9.5 m high (Figs. 3a and 3b). The area disturbed was minimised by restricting pedestrian access to the line of the trench. Placing the large volume of spoil on a ground sheet to reduce the spread of lighter coloured material was not practical on the steep slope, and additional degradation was judged likely if spoil was carried from the top to the bottom and then vice versa. For these reasons, spoil was placed to one side so that sediments of different kinds would not become mixed in a pile at the foot of the slope, and so the broad composition and colour of the material excavated could be replaced as closely as possible to its original position. Small calibre scree was stockpiled separately and larger rocks were also segregated. Excavation, sampling and rehabilitation were accomplished within two days.

Figure 3. Marine Plain scarp trench (site 3); (a) prior to excavation; (b) during excavation, with structural rehabilitation of top section initiated.

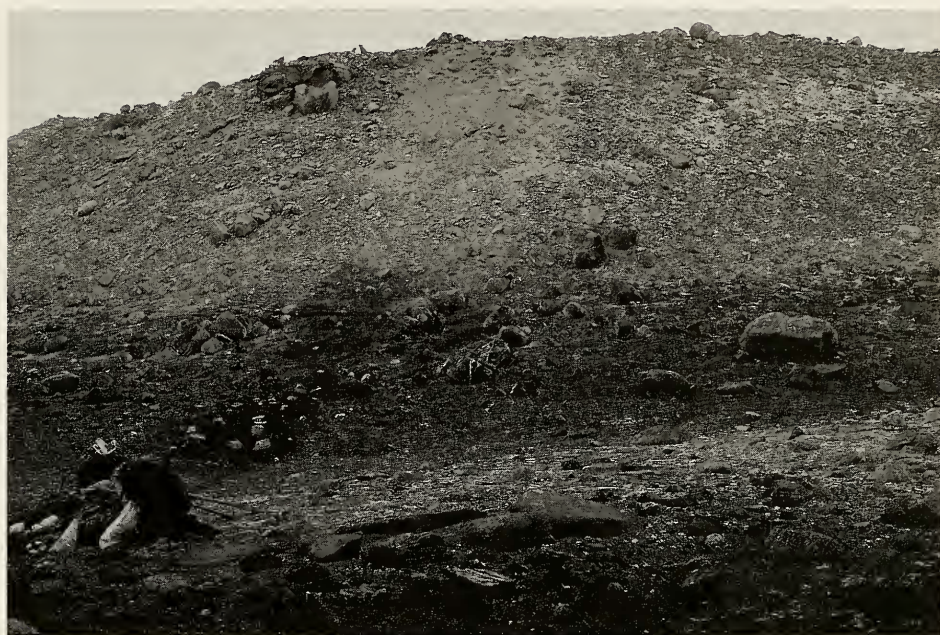
Figure 3c.

At the conclusion of this work on 24 January 1997 a satisfactory mimic of the natural form and texture of the slope had been achieved. However, marked differences between the colours of the surface sediment and exposed subsurface sediments precluded immediate satisfactory visual restoration, the colour contrast between the weathered natural surface and the disturbed subsurface diatomite being very high (up to four Munsell value units) (Fig. 3c). Differences in colour between surface and subsurface glacial clasts contributed to the visual contrast after rehabilitation. However, while this site remained visually evident when viewed from close up, it was less conspicuous from a distance of more than ~200 m because the colour was reasonably similar to that of natural swales that occur locally down the face of the scarp.

Figure 3 continued. Marine Plain scarp trench (site 3); (c) immediately after rehabilitation immediately after rehabilitation in January 1997; and (d) and in December 2000.

During rehabilitation each bench within the trench was used as a foundation upon which returned spoil could be placed, to ensure that any later settling would occur in small localised units rather than being sequentially transmitted down the full length of the trench. Larger rocks were placed towards the outer edge of each bench to retain fine material and the fill was consolidated on a bench-by-bench basis and manually compacted. Restoration was undertaken from the top downwards rather than from the bottom upwards, so that each bench had to be made stable in its own right. The retained scree was utilised in an attempt to mimic the natural veneer of lag gravels in an effort to obtain as natural a surface texture and appearance as possible. Replacement of the original surface clasts weathered side up helped further reduce the visual impact. As the rehabilitation proceeded, periodic checks were made on its appearance from a distance so that adjustments could be made.

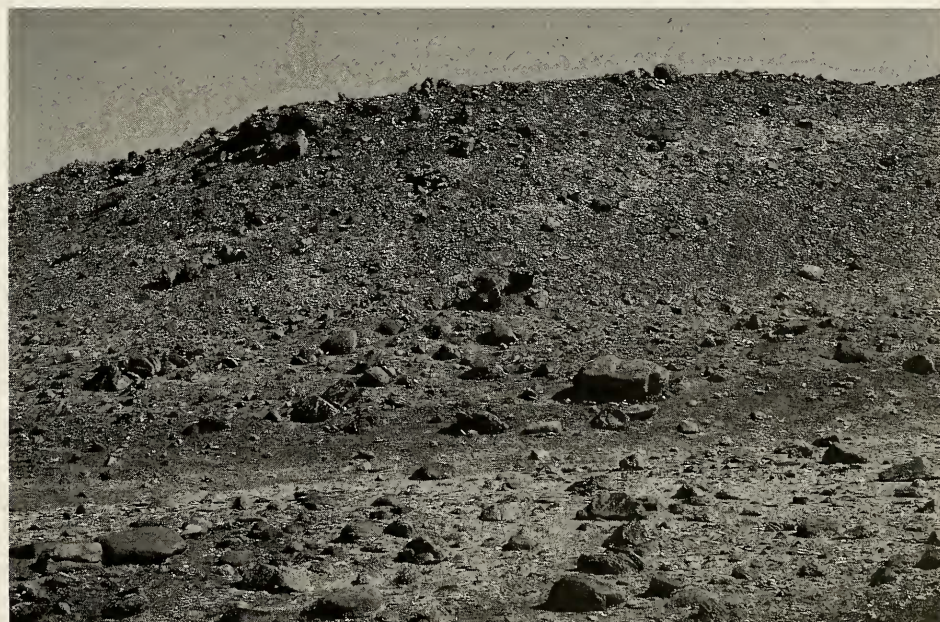
Figure 3d.

When monitored on 11 December 2000 the trench site was superficially indistinguishable from its appearance prior to excavation (Fig. 3d). There was no evidence of any slumping or downslope flow, suggesting that construction of the subsurface rehabilitation was adequate. Nor was there any evidence of lateral subsidence that might be attributable to melting of ground ice, nor of any discharge of fine material or salts onto the surface. This suggests the thickness and thermal characteristics of the deliberately re-consolidated infill provided a reasonable mimic of the original active layer. The small volume of fine subsurface dust that discoloured the ground surface immediately after initial rehabilitation was no longer evident, presumably having weathered or been removed by the wind, the latter implying diffuse contamination downwind. The scatter of small calibre gravel applied to the surface during rehabilitation could not be differentiated from the natural material to either side of the disturbed area. An equally satisfactory result was obtained after rehabilitation of an associated soil pit at the crest of the scarp (Table 2, site 4).

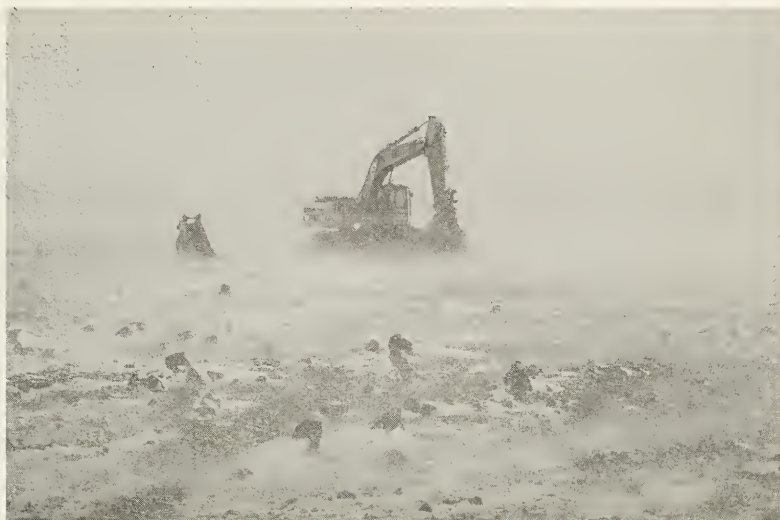
Figure 4a.

Figure 4. Heidemann Bay trench (site 9) (a) during rehabilitation under blizzard conditions; (b) linear depression formed in rehabilitated surface between March 1997 and December 2000.

winds of 40-45 knots and blowing snow (Fig. 4a). This might have posed the risk of sediment being blown considerable distances had the moist condition of the spoil not by now become even more pronounced due to continued permafrost melting. The position of the trench and direction of the wind meant that any dust generated would be carried into the sea rather than contaminate soil surfaces, but after re-filling there was no evidence of dust on the snow any further than 5 m downwind. The excavator was used to compact the fill and to rake the surface. The sediment fitted back in the hole with negligible surface mound remaining, a result attributed to some mass loss having occurred through melting of ground ice.

No work was undertaken the next day as the blizzard continued. The following day was devoted entirely to rehabilitation, initially involving work with the excavator, which was then driven from the site, again with the ground impact reduced by a layer of new snow. Manual rehabilitation of the ground surface using spades, mattocks and rakes initially involved digging snow out of ruts made by the excavator so that these could be smoothed. This snow was later scattered across the rehabilitated area to maximise the available soil moisture and enhance the potential for frost heaving. This work was made much easier by the fact that insufficient time had elapsed to allow the disturbed ground to compact and harden. Care was taken to avoid smoothing the ground to such an extent that the rehabilitated surface appeared flatter and smoother than the natural surface surrounding it. Some retained glacial rocks were scattered back across the site with their weathered upper surface uppermost. Efforts were made to smooth the transition between disturbed and undisturbed ground to soften the contrast in colour and texture. These same procedures were employed along the full length of the access route (sites 7 and 8). The impact of two passes by the excavator proved visually less than that caused by several traverses by a four wheel drive vehicle used to carry other equipment and heavy materials to the site. The hand-tool phase of the rehabilitation process took ~2.5 person days.

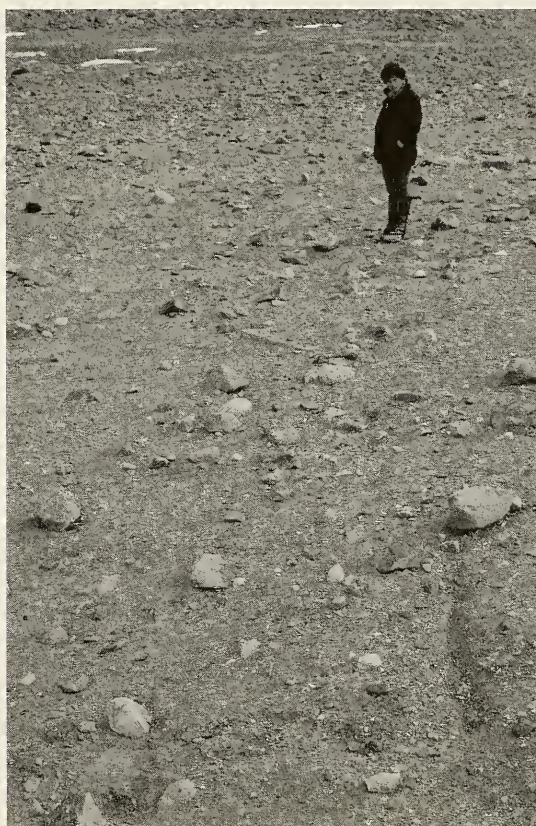
Figure 4b.

When monitored on 14 December 2000 the trench site could not be located visually on the ground without using photographs. Once the target area had been located accurately a slightly darker colouration and slight relative scarcity of surface rocks was discerned where spoil had been stockpiled. A subtle linear depression a few centimetres across, less than 1 m long and up to 5 cm deep was found to have formed along the line of the trench and to have been partly filled by in-washed fine sediment (Fig. 4b). Though visually similar to nearby natural features, this depression may reflect either settling of the spoil or frost cracking, also conceivably triggered by the disturbance. Neither the trench site nor access route were readily discernible upon overflying the site at ~50 m altitude. That part of the older vehicular track that was re-used and rehabilitated in 1997 (site 7) was just discernible at ground level, but the precise location of the rehabilitated cross-country access route (site 8), traversed by the excavator, 4WD vehicles and pedestrians, could no longer be discerned (Figs 5a and 5b). The un-rehabilitated parts of the older bull-dozer track remained conspicuous.

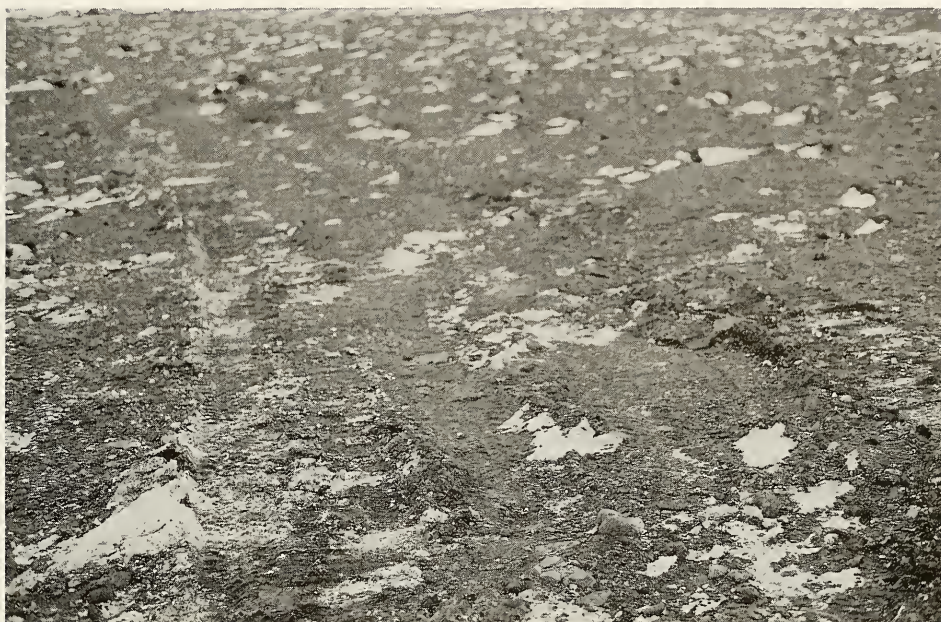
Figure 5a.

Figure 5. Heidemann Bay cross-country access track (site 8); (a) before rehabilitation in March 1997; (b) in December 2000. The trench site (site 9) is immediately behind and to the right of the researcher.
